Case Study for
Safety Tools Allmet A.S. on
Aker FPSO: DHIRUBHAI-1

OCS Services

To provide Fabric Maintenance services on Aker FPSO Dhirubhai-1 in EX Zones with the aim to preserve it without becoming a hurdle to different on-going unit activities on-board and put forward to the client management as an easy, single point base contact for all Coating application / Asset preservation activities.

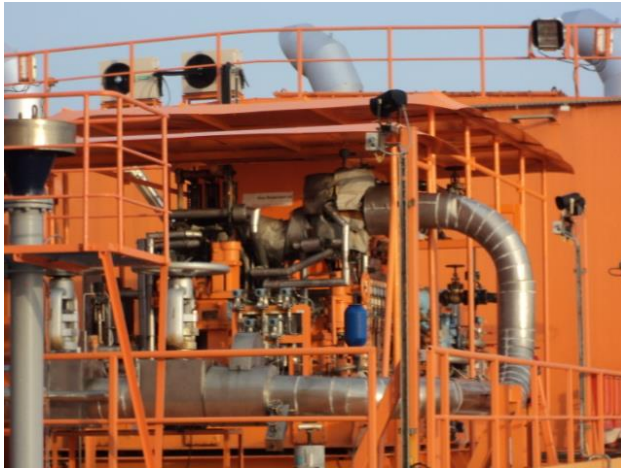
After final coat in U-10

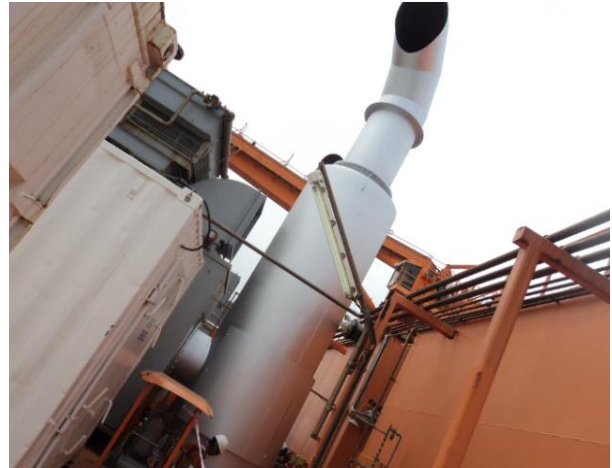
After final coat on solar funnel in U-70

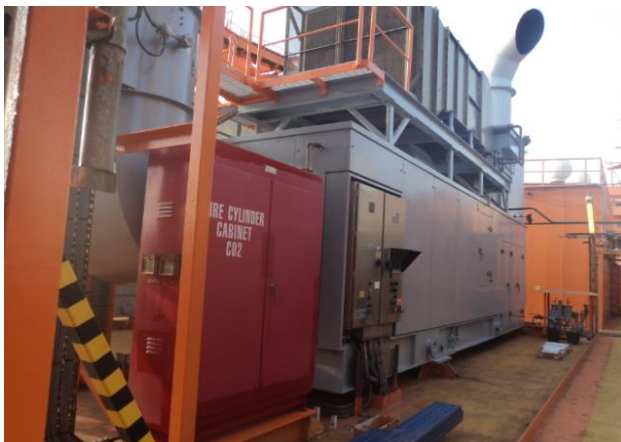
After final coat on solar in U-70

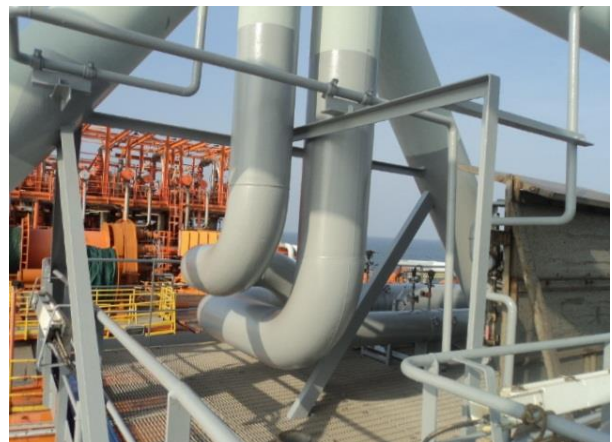
After final coat in F-10

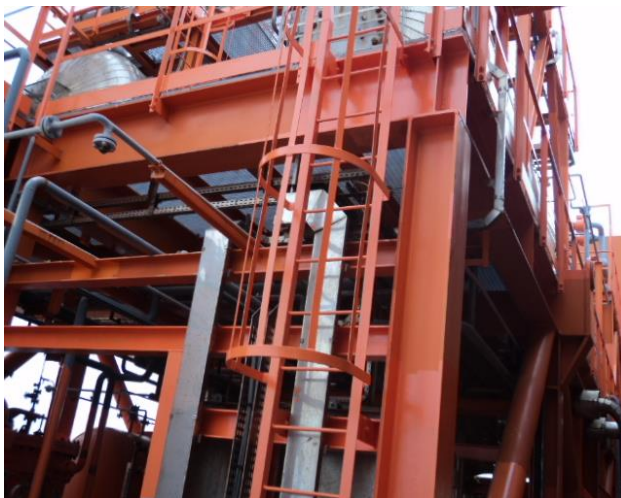
After final coat in U-71area

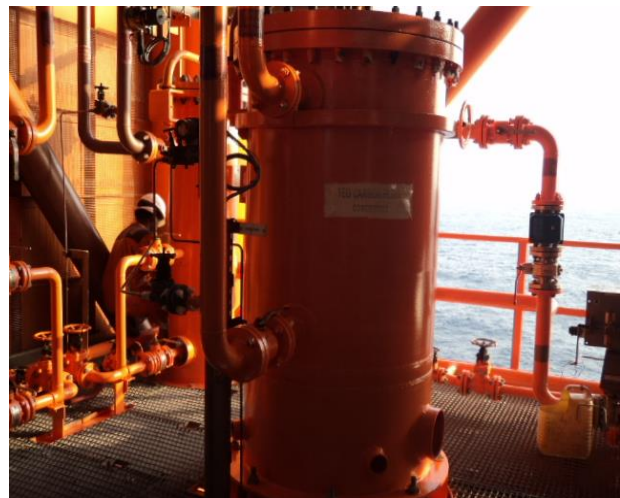
After final coat in U-71area

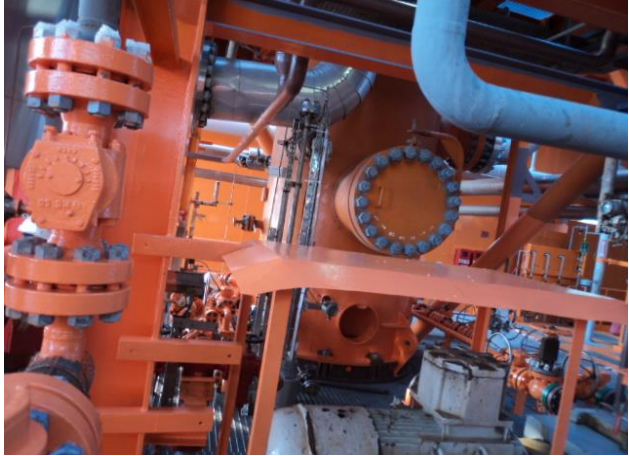
After final coat in U-71area

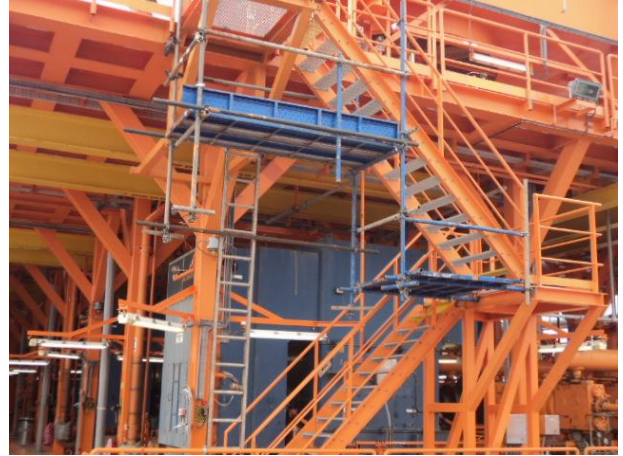
After final coat in Gas Compressor Area

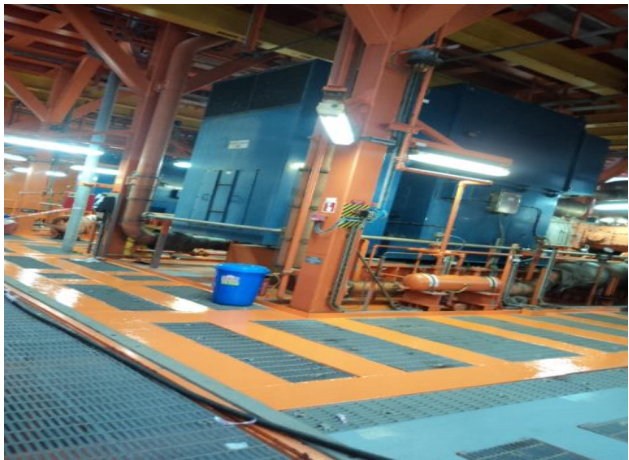
After final coat in Gas compressor area

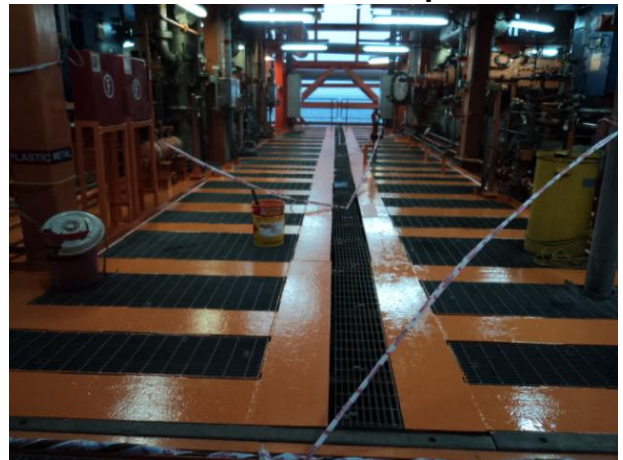
After final coat in Gas Compressor area

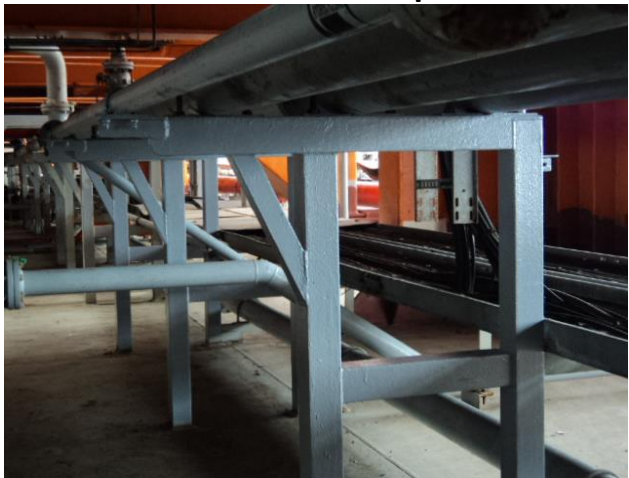
After final coat below main deck

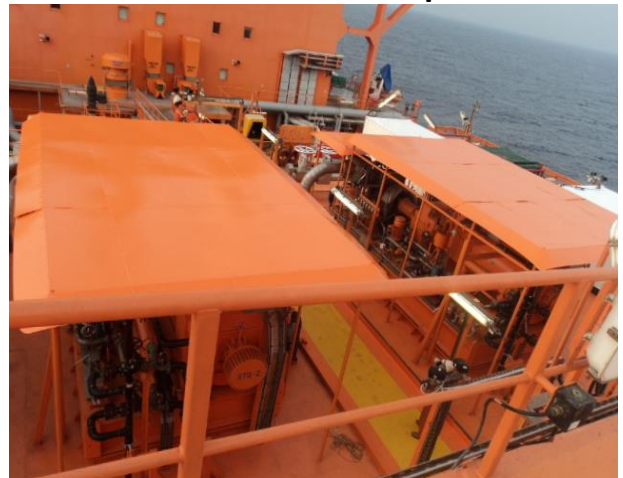
After final coat in U-10area

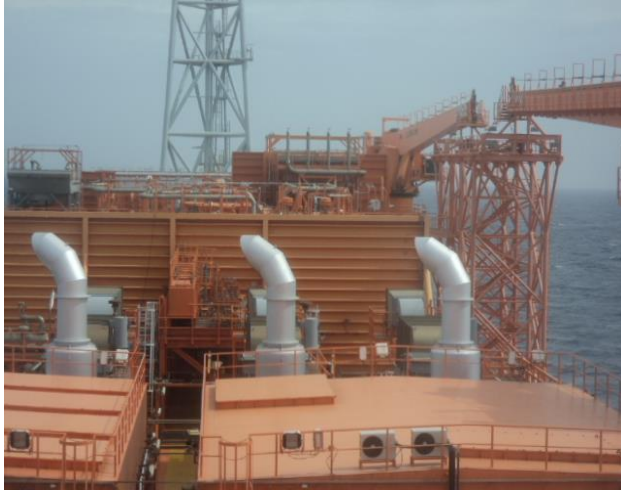
After final coat in U-20 & solar area

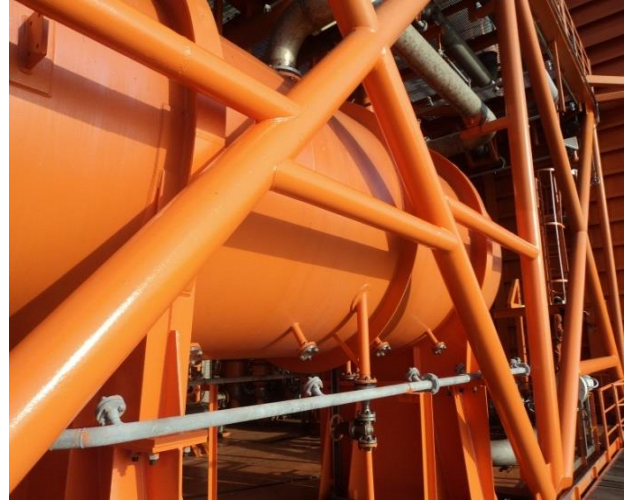
After final coat in P-10 area

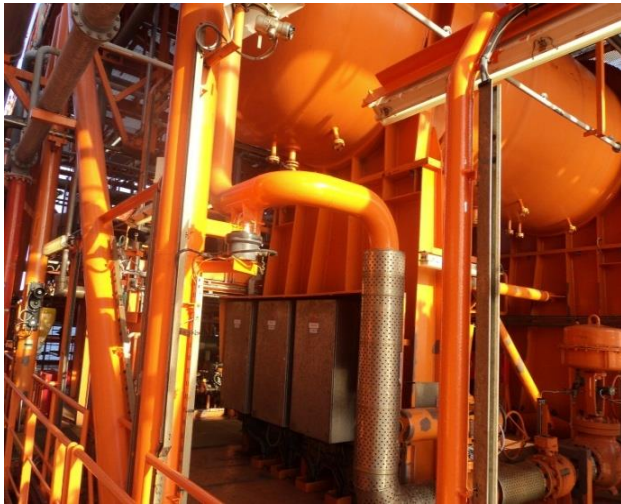
After final coat in P-10 area

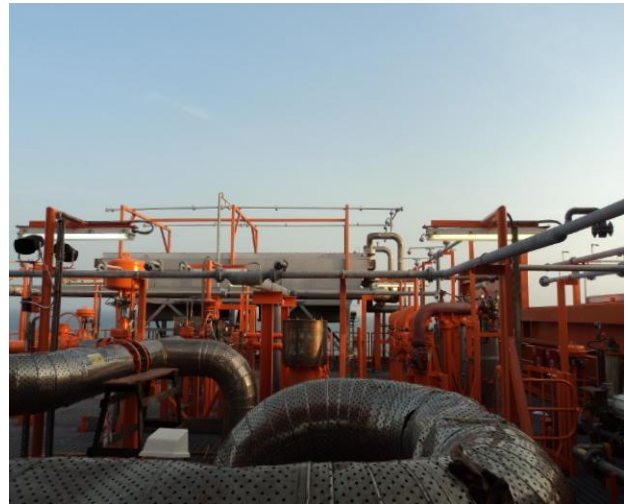
After final coat in P-10 top side

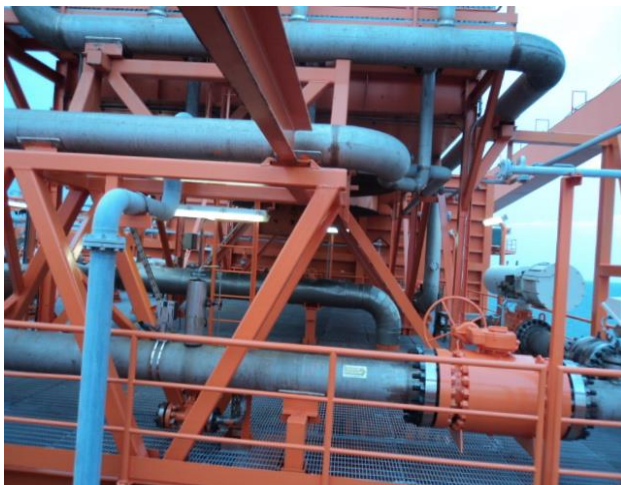
After final coat in P-10 top side

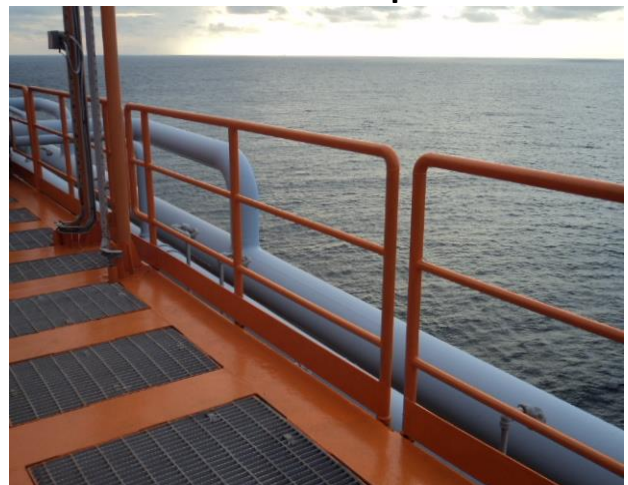
After final coat on top side of gas compressor area

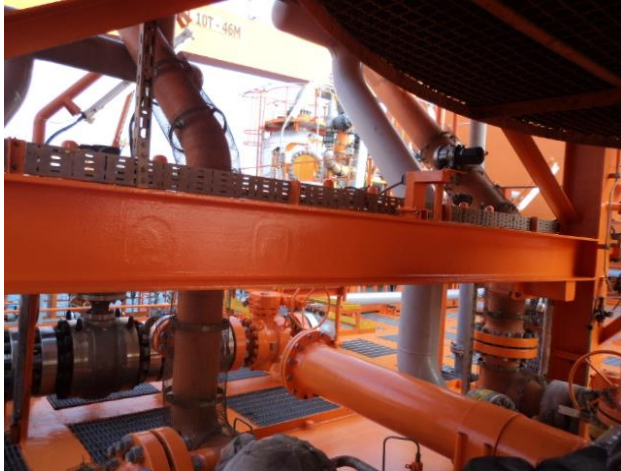
After final coat on top side of gas compressor area

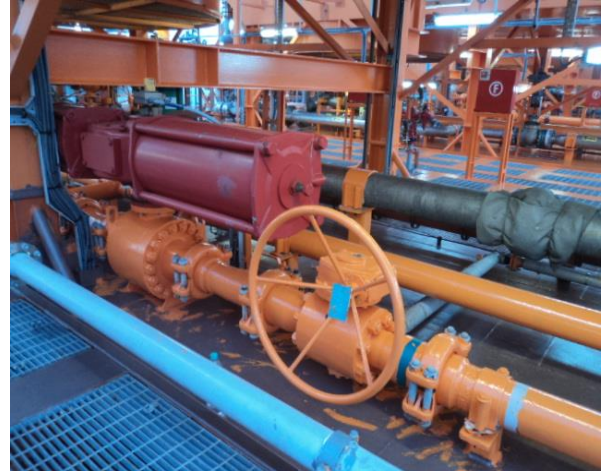
After final coat on top side of gas compressor area

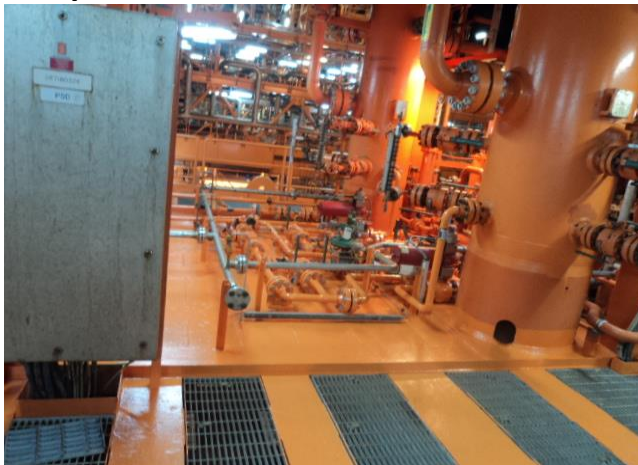
After final coat in gas compressor area

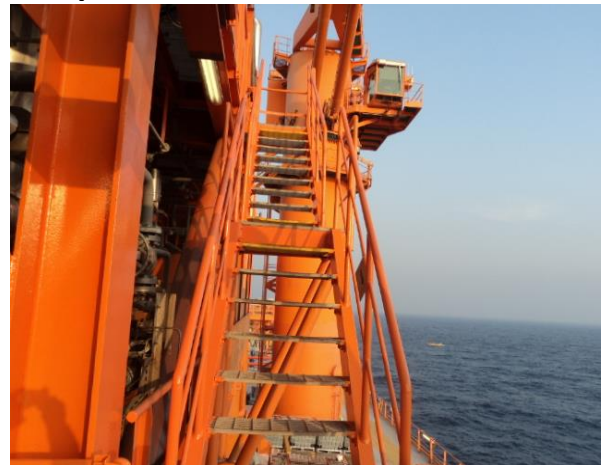
After final coat in gas compressor area

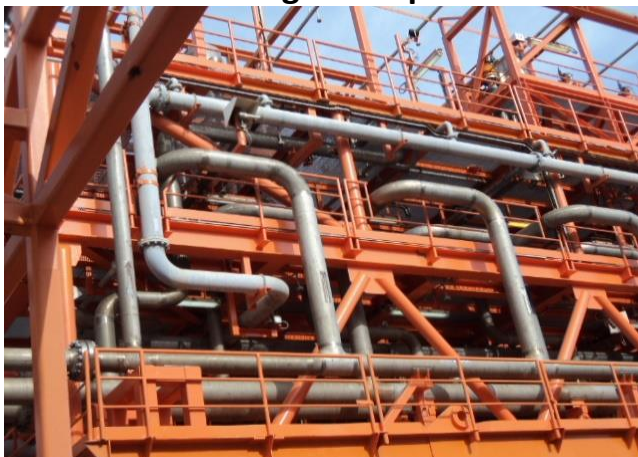
After final coat in U-30

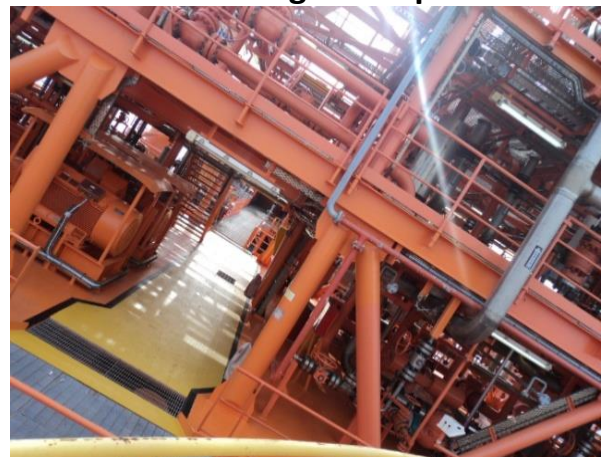
After final coat in U-30

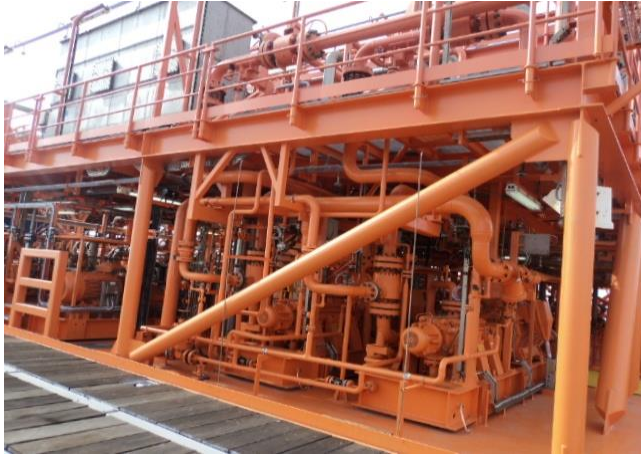
After final coat in U-30

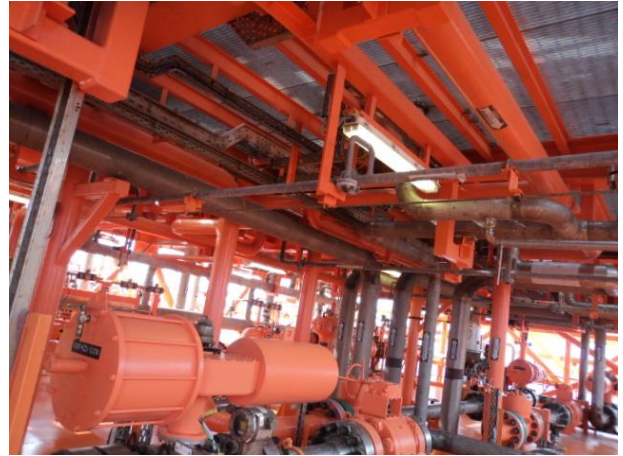
After final coat in U-30

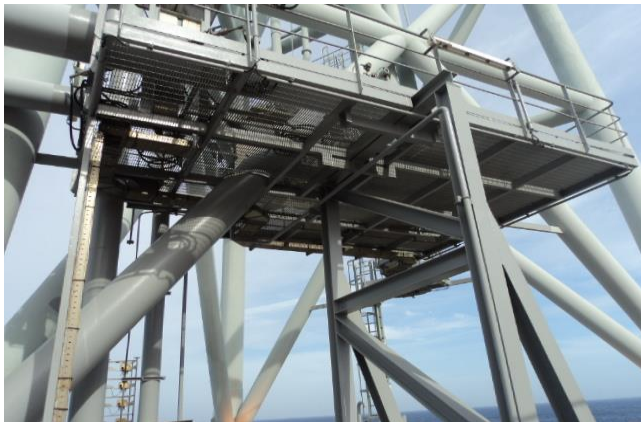
After final coat in F-10

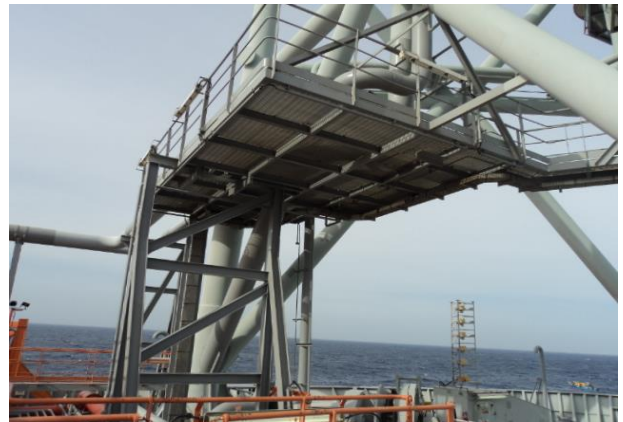
After final coat in F-10

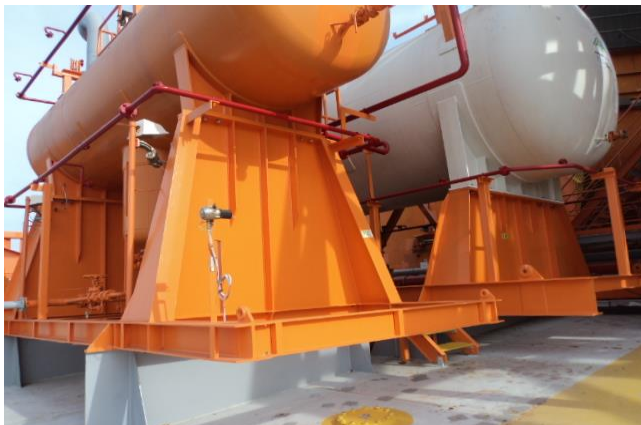
After final coat on P-40 & P-41area

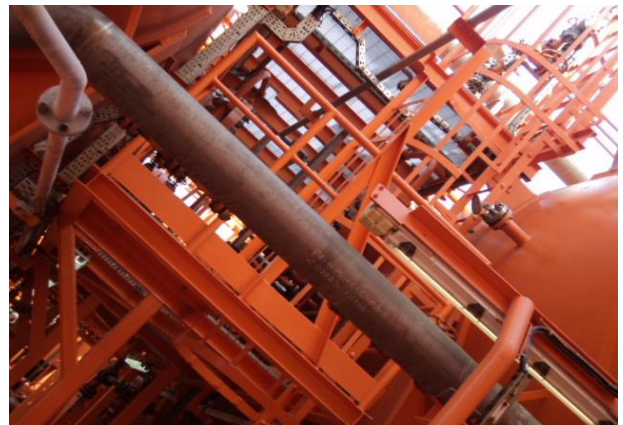
After final coat in P-11

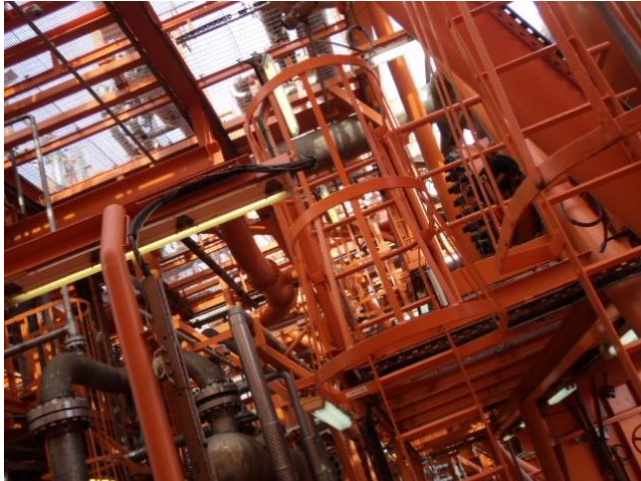
After final coat in P-11

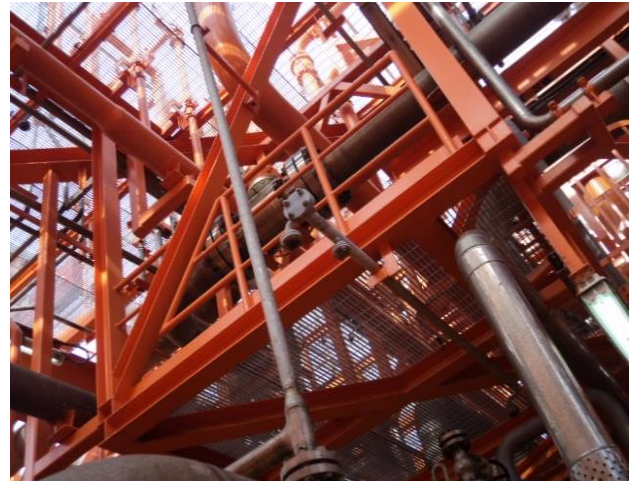
After final coat in P-10

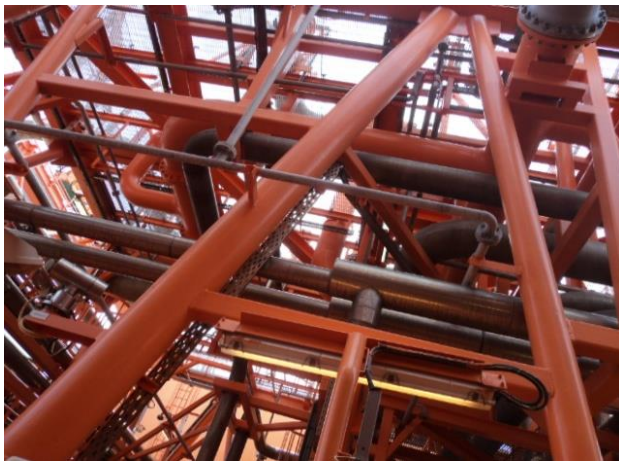
After final coat in P-10

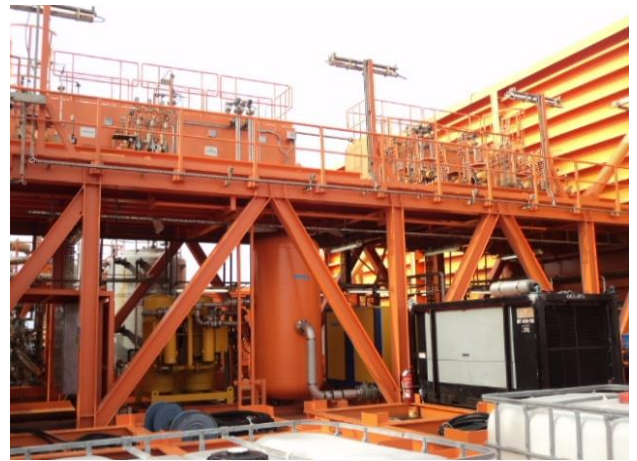
After final coat in U-70

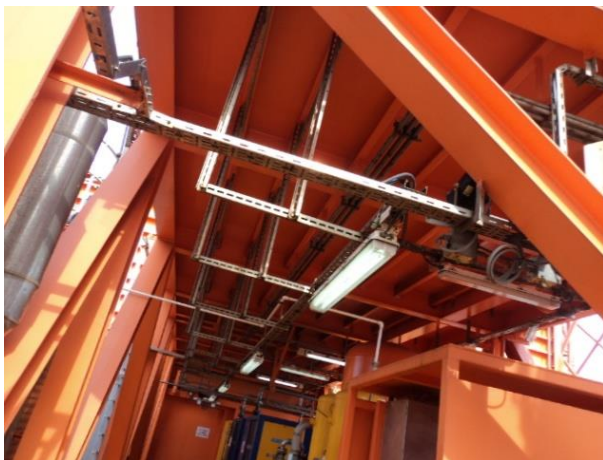
After final coat in U-70

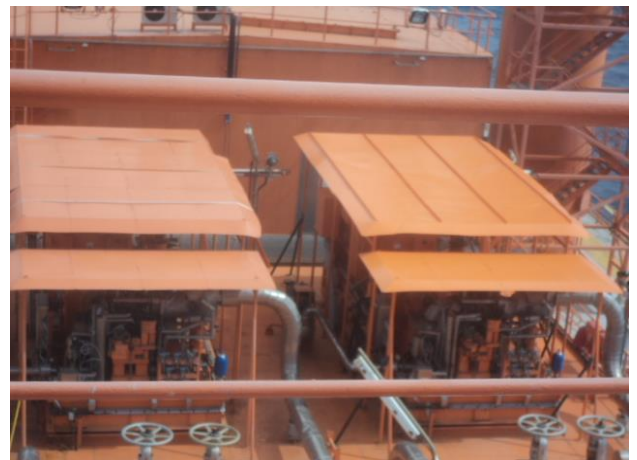
After final coat in U-10
